Detailed analysis of allergic cutaneous reactions to spinal cord stimulator devices

Abstract: The use of spinal cord stimulation (SCS) devices to treat chronic, refractory neuropathic pain continues to expand in application. While device-related complications have been well described, inflammatory reactions to the components of these devices remain underreported. In contrast, hypersensitivity reactions associated with other implanted therapies, such as endovascular and cardiac rhythm devices, have been detailed. The purpose of this case series is to describe the clinical presentation and course of inflammatory reactions as well as the histology of these reactions. All patients required removal of the entire device after developing inflammatory reactions over a time course of 1–3 months. Two patients developed a foreign body reaction in the lead insertion wound as well as at the implantable pulse generator site, with histology positive for giant cells. One patient developed an inflammatory dermatitis on the flank and abdomen that resolved with topical hydrocortisone. “In vivo” testing with a lead extension fragment placed in the buttock resulted in a negative reaction followed by s

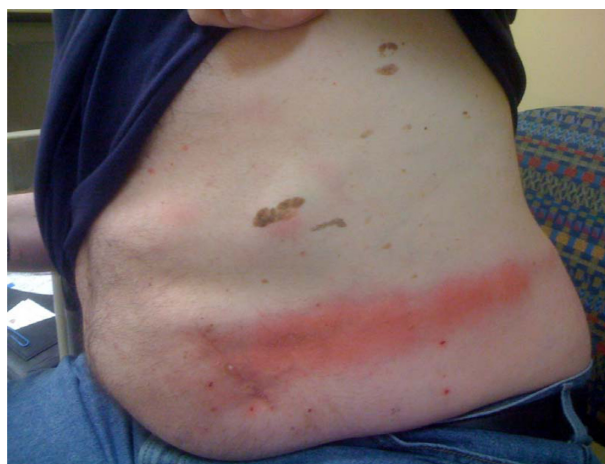
He was seen one week after the operation and his wounds, which included the abdomen for the generator, flank for the extension, and back for lead insertion and anchoring, were noted to be dry with intact incisions, and no erythema, drainage, or tenderness. He was afebrile. At one month post operation, the patient developed a left-sided rash on his flank and abdomen, with no fevers or chills (Figure 1). The stimulator was working well, providing up to 60% pain relief. The incisions over his abdomen, flank, and back were well healed. However, he had an area of erythema/dermatitis that seemed to be localized to the area over the length of the lead extensions connecting the implantable pulse generator to the leads. The reaction did not involve the implantable pulse generator site. It was noted that this rash appeared to

Figure 1 Erythematous rash on the abdomen and flank (case I) primarily overlying the lead extensions.

be an area of reactive inflammation, as opposed to infection, and he was diagnosed with a hypersensitivity reaction to the implanted wires. He was given topical 1% hydrocortisone cream and seen 7 days later, with resolution of the rash.

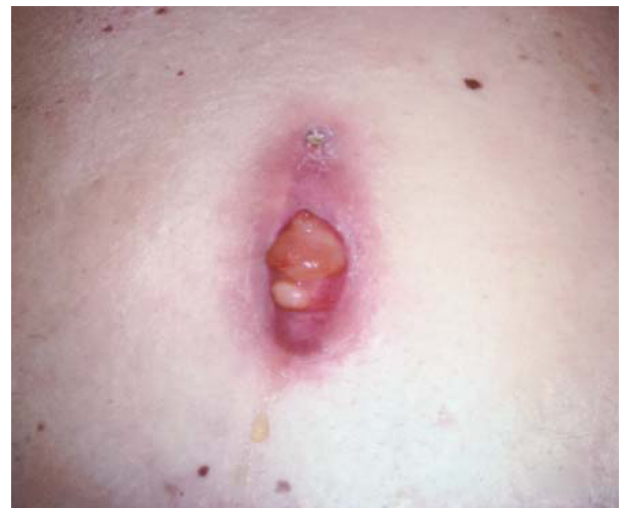
However, despite resolution of the infection, the patient still had a skin inflammatory change that persisted for 5 weeks following implantation (Figure 4). Because of poor

Figure 4 Persistent inflammatory reaction on the upper back (L2 level) 5 weeks post implantation in case 2. Lead strain relief is directly under the inflammatory tissue.

wound healing, the decision was made to remove the dual leads, silastic anchors with associated 0 silk sutures, and the implantable pulse generator. Intraoperative frozen sections revealed acute and chronic inflammation, with a foreign body giant cell reaction (Figure 5A and B). The removal of the soft inflammatory tissue in Figure 4 revealed the underlying leads, and the pocket floor of the implantable pulse generator that had excess lead coils was notable for soft tissue inflammation. Similarly, the tissue was very friable and bled easily with manipulation. Interestingly, there was no fibrotic tissue deposition surrounding the leads, anchors, or the floor of the implantable pulse generator pocket. Normal wound healing then proceeded with an uneventful recovery.

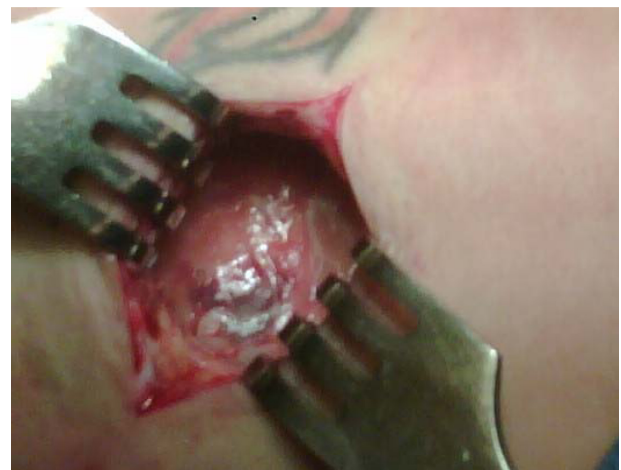
was 13.8. The implantable pulse generator was subsequently removed at approximately 11 weeks post implantation. An inflammatory reaction of the pocket floor was noted with very friable tissue (Figure 7). The fibrous floor of the pocket that is usually well formed at 3 months post-implantation was disrupted by inflammation. There were no signs of purulence or infection. A week later, all her wounds were healing well and the drainage had ceased from the buttock.

Figure 7 Open wound of the right buttock with implantable pulse generator. The floor of the pocket has modest fibrous tissue with a collection of friable reactive tissue.
