Evaluating Fracture Resistance And Failure Modes Of Root Filled Teeth Restored With CAD/CAM-Fabricated Post And Core

This article was published in the following Dove Press journal:
Clinical, Cosmetic and Investigational Dentistry

Objective: The aim of this study was to measure the fracture resistance and failure modes of root-filled teeth restored with three different computer-aided design/computer-aided manufacturing (CAD/CAM)-fabricated post and core assemblies.

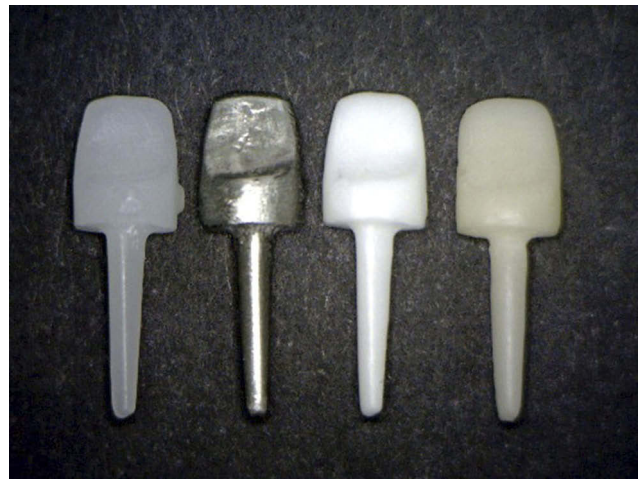
Figure 1 Standardized cast post and core teeth. From the left; CAD/CAM milled wax post and core, cast metal post and core, CAD/CAM milled Zirconia post and core, and CAD/CAM milled PICN post and core.

The post pattern was fabricated by using a prefabricated polycarbonate post that was relined with acrylic resin until passive retention was achieved. The core was fabricated using the same material, and the measurements were standardized: buccal height (5 mm), cingulum height (2 mm), buccopalatal width cervically (5.5 mm) and incisally (1 mm), mesiodistal width cervically (5 mm) and (4.5 mm) incisally (Figure 1).

The resulting standard post and core pattern was scanned using a 3D Ceramill Map 300 scanner (Amann Girrbach AG) to obtain a digital 3D model, and the data were transformed into a standard template library (STL) (Figure 2). The mill command was given to a CAD/CAM Ceramill Motion 2 milling machine (Amann Girrbach AG) to begin the milling of the zirconia (Ceramil ZI, Amann Girrbach AG) post and core. The STL design data were used to fabricate 10 PICN (Vident, Brea, CA, USA) post and core assemblies using a different milling unit (Galaxy BioMill, Biolase, USA) (Figure 1).

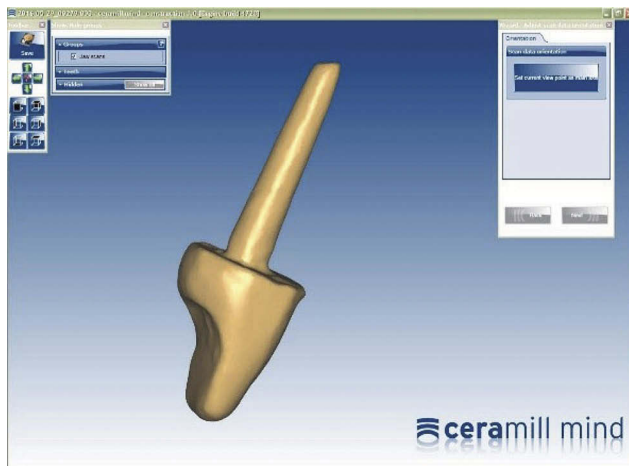
Figure 2 Image of scanned three-dimensional post and core tooth using CAD/CAM Ceramill Mind software. Image courtesy of Amann Girrbach GMBH, Pforzheim, Germany.

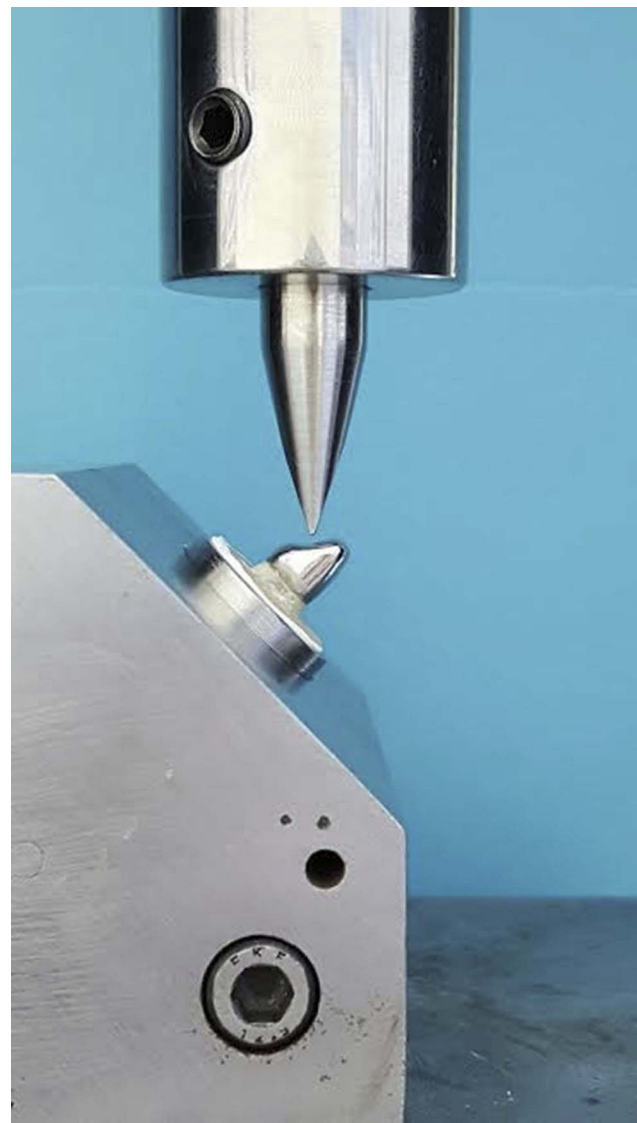
Figure 3 The image shows custom-made assemblies, starting from the superior part; the chisel head is pointed at 135° on the palatal surface of the tested tooth.

Each specimen (post and core covered with crown) was mounted with a metal cylindrical mold on a steel custom-made block with an inclination of 45°. Then, the specimen was subjected to fracture resistance test using a universal testing machine (Testometric, UK). The force was loaded with a custom chisel head (size 1.2 mm) at a crosshead speed of 1 mm/min. The force was applied at an angle of 135° to the long axis of the crown on the palatal side (Figure 3). The point of fracture was defined by an abrupt drop in the strain–stress diagram, and the fracture was recorded as the point at which the loading force reached a maximum value.⁷ The test was continued until there was split or fracture of the root, which was examined under a stereomicroscope (Pysen-SGI Limited, Edenbridge, UK) to determine the failure mode. The failure was considered favorable and potentially repairable when it was represented by a fracture of the post only or root fracture

The angle between the tooth sample and the testing machine was 135° to mimic a normal clinical situation consisting of the angle formed between the long axis of the mandibular central incisor and maxillary central incisor.³¹ The findings of this study revealed that the force of resistance to fracture was nonsignificant between study groups (metal, zirconia, and PINC), which indicates that PINC could be a suitable option for restoration of incisors requiring a custom post-core. Although PINC was the material with the least fracture resistance, it remains the material of

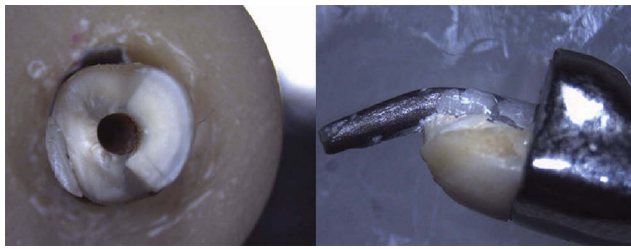
Figure 4 Stereomicroscopic images show a nonfavorable fracture in the metal group; notice the bending of the metal post.

All samples in the metal and zirconia groups exhibited nonfavorable fractures, which could be related to a mismatch in the modulus of elasticity between the root dentin and post material. Another explanation is that there was a difference in the stress distribution of the load on the restoration system, which contained different rigidity components. The component with high rigidity is able to resist forces without distortion, and the stress transfer to the component with less rigidity causes fracture.⁹ The distribution of the occlusal forces along the root length is affected by the rigidity of the post, which should be close or equal to the rigidity of the root itself.³⁵

In the present study, the posts and cores in the metal group exhibited no fracture due to the superior bending characteristic and high elastic modulus of the metal in comparison to that of the tooth structure, while the samples in the zirconia group exhibited a combined post-root fracture. This is supported by the study by Soundar et al,³⁶ who noted that all samples with cast metal post-cores exhibited tooth fracture, while all-ceramic post-core samples revealed fracture of the post.

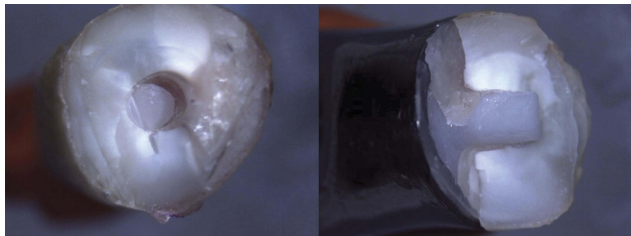
Figure 5 Stereomicroscopic images show a nonfavorable root fracture and post-core fracture in the zirconia group.

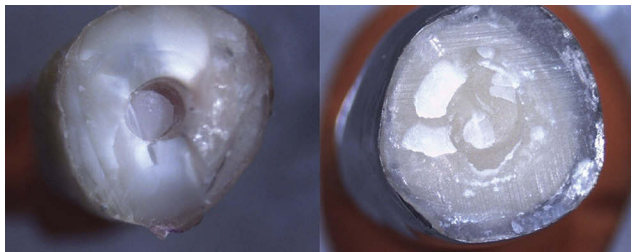
Figure 6 Stereomicroscopic images show a favorable root fracture and post-core fracture in the PICN group.

For the PINC group, seven samples exhibited a nonfavorable fracture, and three samples showed a favorable fracture represented by postfracture only. The presence of both modes of failure in the PINC group is related to the differences in the elastic modulus between PINC and the root dentin of the study samples. When the elastic modulus of PINC (30 GPa) is close to that of dentin with a range of 10–30 GPa,⁵ this will lead to the creation of a mechanically homogenous unit,³⁷ and favorable fracture will occur. This
